PROGRESS REPORT

August 1, 1966 through April 30, 1967

THE ADHERENCE OF PORCELAIN ENAMEL TO ALUMINUM

421.04-12-4212270

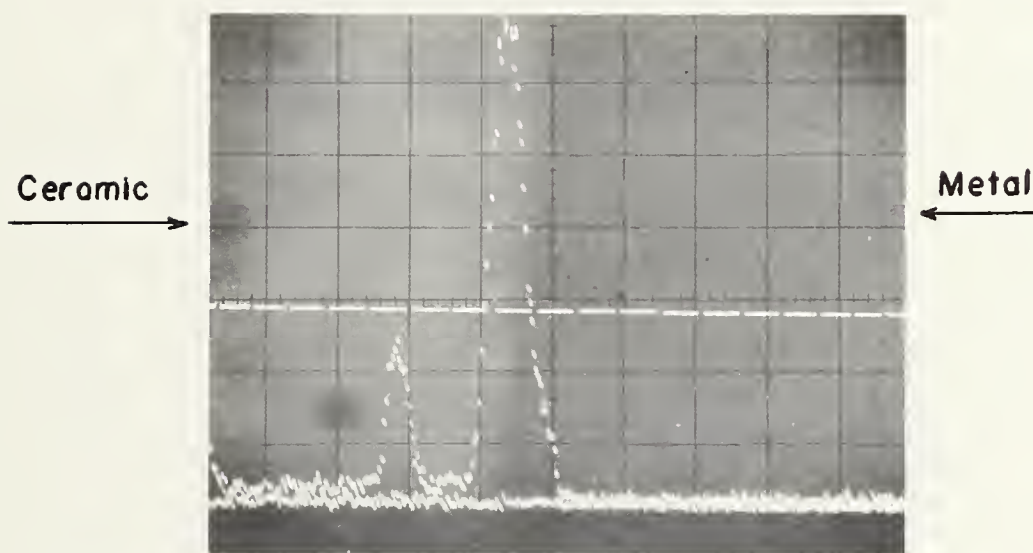
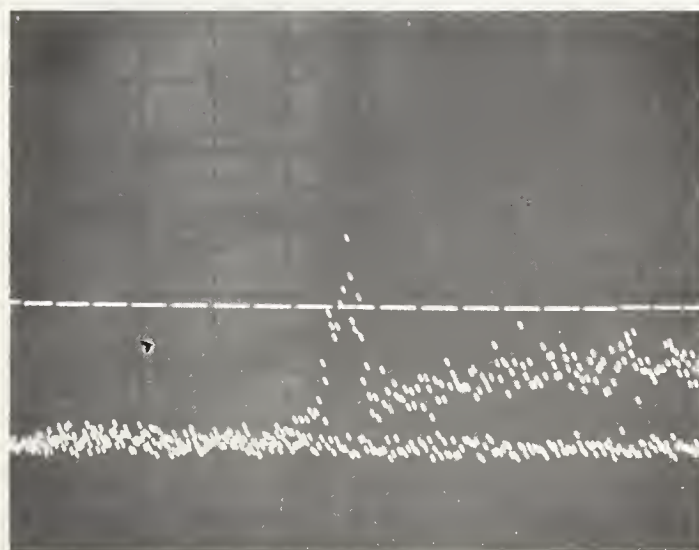
6061 Aluminum Alloy

Figure 16 Target Current Plus CuK_α

Figure 17 Target Current Plus CrK_α

Figure 18 Target Current Plus MgK_α

Figure 19 Target Current Plus CuK_α

Figure 20 Target Current Plus CrK_α

Figure 21 Target Current Plus MgK_α

Cross-section samples were submitted for electron microprobe analysis of the interface. Initially samples of 1100 and 6061 were submitted. Both alloys had been chemically cleaned for seven minutes and then subjected to an R-100 ¹ bath for ten minutes prior to enameling. The 1100 sample exhibited good spall resistance and the 6061 sample exhibited failure. Both samples were tested using the antimony trichloride spall test. Traces for all the elements contained in the two samples showed no marked difference, so a sample of prefired 5154 alloy was added and traces of the elements aluminum, magnesium, lead and silicon were obtained. Figures 1-4, 5-8, and 9-12 show these traces on the 1100, 6061 and 5154 samples respectively. As a follow-up to this work, samples of 5154 with a seven minute chemical clean, ten minute R-100 pretreatment prior to enameling, and samples of prefired 6061 and 5657 were submitted and traces were obtained for magnesium, copper and chromium. Figures 13-15, 16-18 and 19-21 show these traces on the 5154, 6061 and 5657 samples respectively. The microprobe shows no evidence of aluminum or other elements diffusing from the substrate into the enamel. However, the resolution of the microprobe is not critical enough to indicate diffusion of less than about 3 1/2 microns since the area being analyzed by the probe is approximately 3 1/2 microns in diameter. Concentrations of magnesium are noted at or near the interface of the magnesium bearing alloys except for the sample of 5154 which had been chemically cleaned and treated with R-100 prior to enameling. 5154 is a magnesium alloy whereas 6061 is a magnesium silicide alloy. The fact that magnesium is more soluble in the R-100 bath than magnesium silicide could account for the disappearance of the magnesium peak on the second sample of 5154 as opposed to the peaks being evident on both of the 6061 specimens.

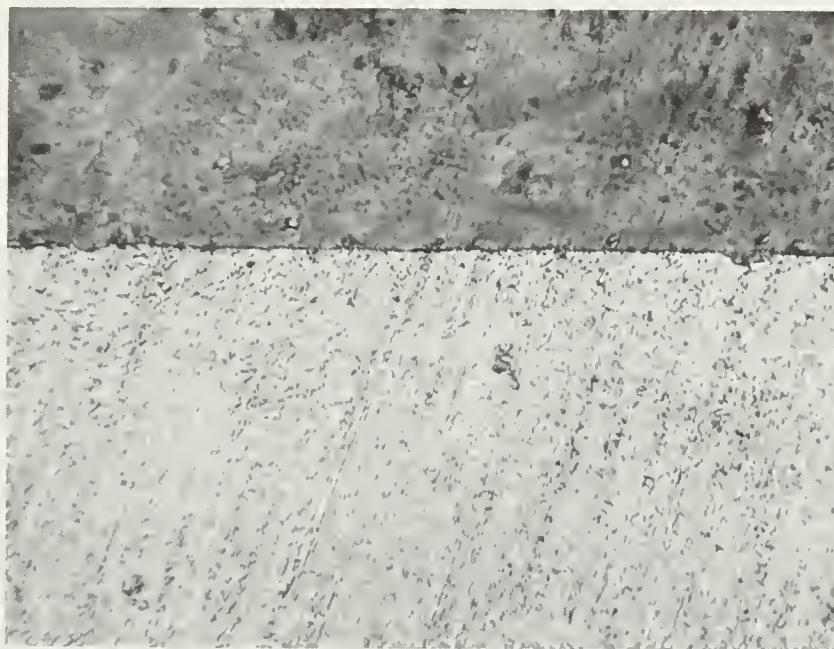
Figure 26. 625X
Alloy 1100 Chemical clean plus R-100
90 degree cross section

A number of photomicrographs were taken of various alloys after enameling. Magnifications up to 875X failed to reveal any definitely identifiable zone of reaction in the interface area. In several instances, what appeared to be banded zones at the interface were later concluded to be due to relief occurring during the polishing of the samples. See figures 26 and 27 for examples of light micrographs.

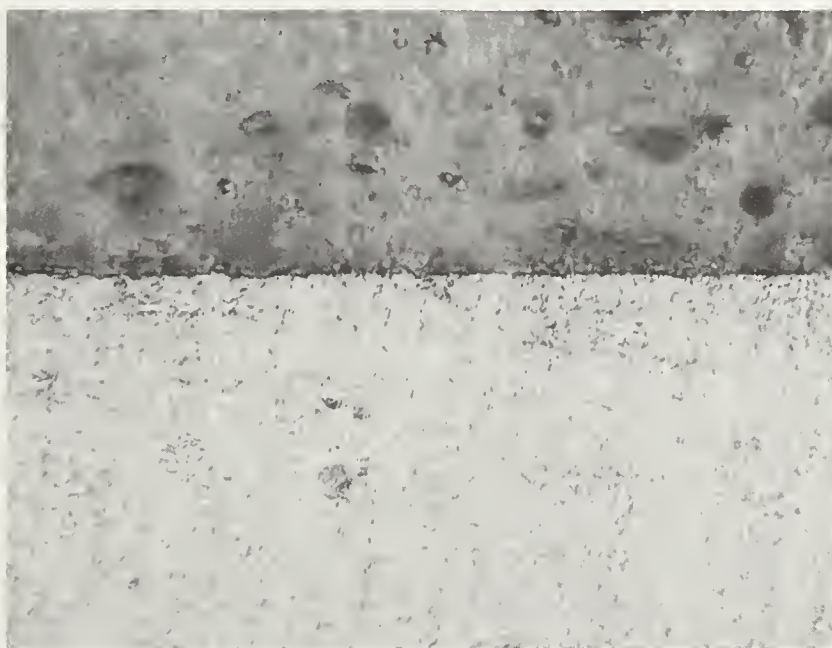
Figure 27. 625X
Alloy 6061 Chemical clean plus R-100
90 degree cross section
